Bravo

Troubleshooting Guide

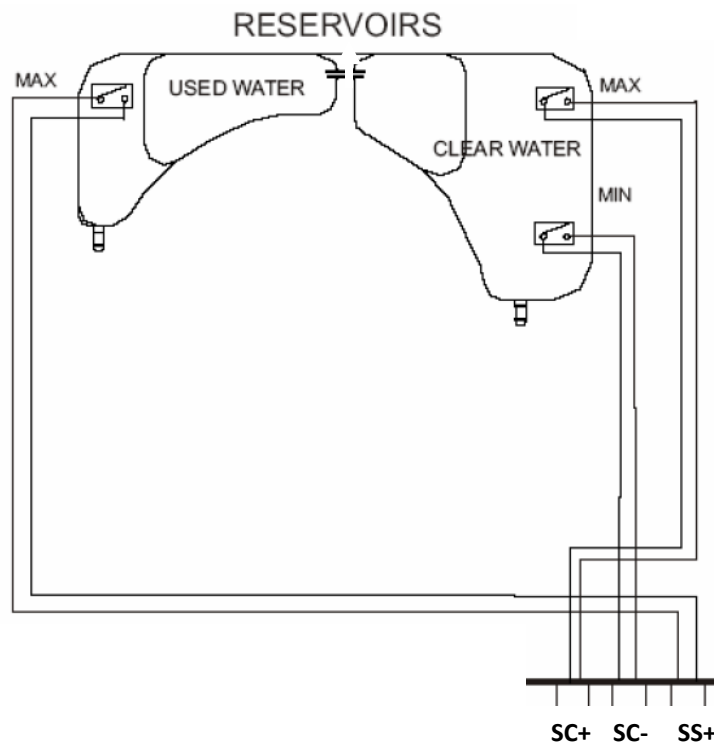
The float switch wires connect to the top of the PCB on the left. The waste water tank switch connects to terminal SS+, The clean water reservoir lower switch (minimum level) connects to terminal SC- and the clean water reservoir upper switch (maximum level) connects to terminal SC+.

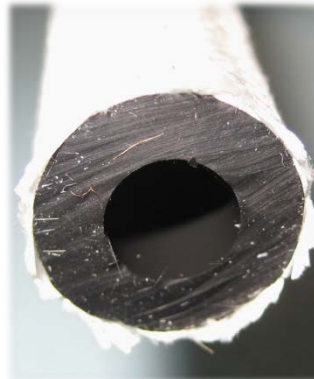
New Tubing

Replace tubing from water pump to steam generator and tubing from steam generator to chamber.

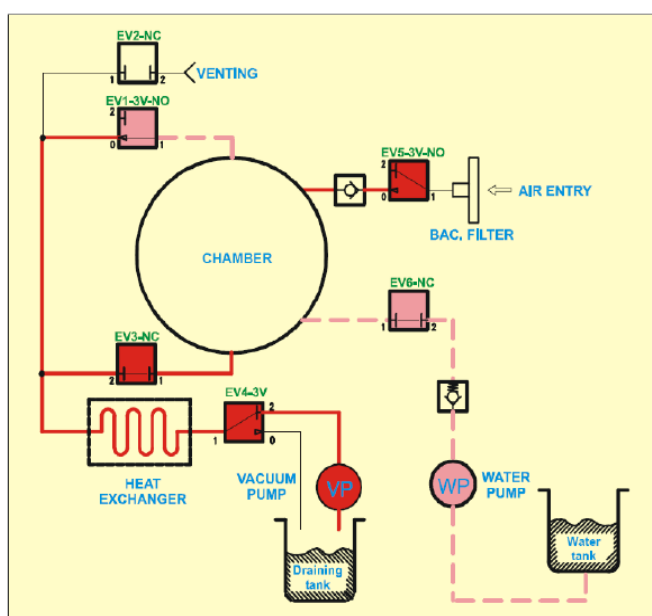
EV6 – Normally Closed

Valve is mechanically closed when OFF.
